# TEST REPORT

Report No.: GTS20250811007-2-01

<b>Applicant</b>	Shenzhen Techtion Smart Electronics Co., Ltd.
<b>Manufacturer</b>	Shenzhen Techtion Smart Electronics Co., Ltd.
<b>Sample name</b>	Outdoor Reflective and Transflective Display Screen
<b>Specification Model</b>	TS-280PHD
<b>Approval Types</b>	IP65 Test

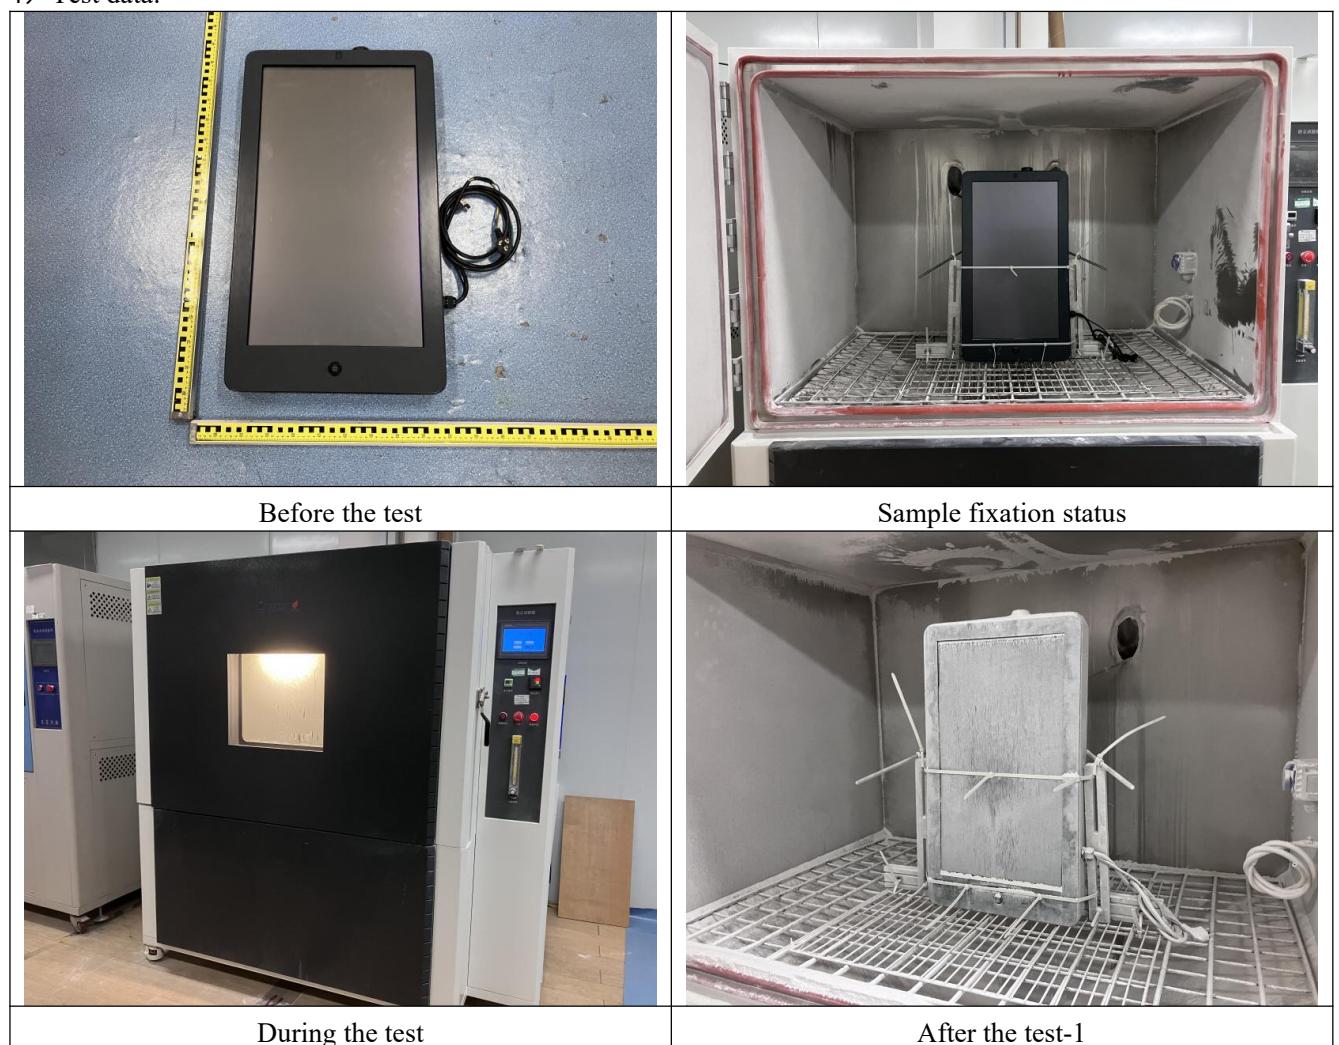
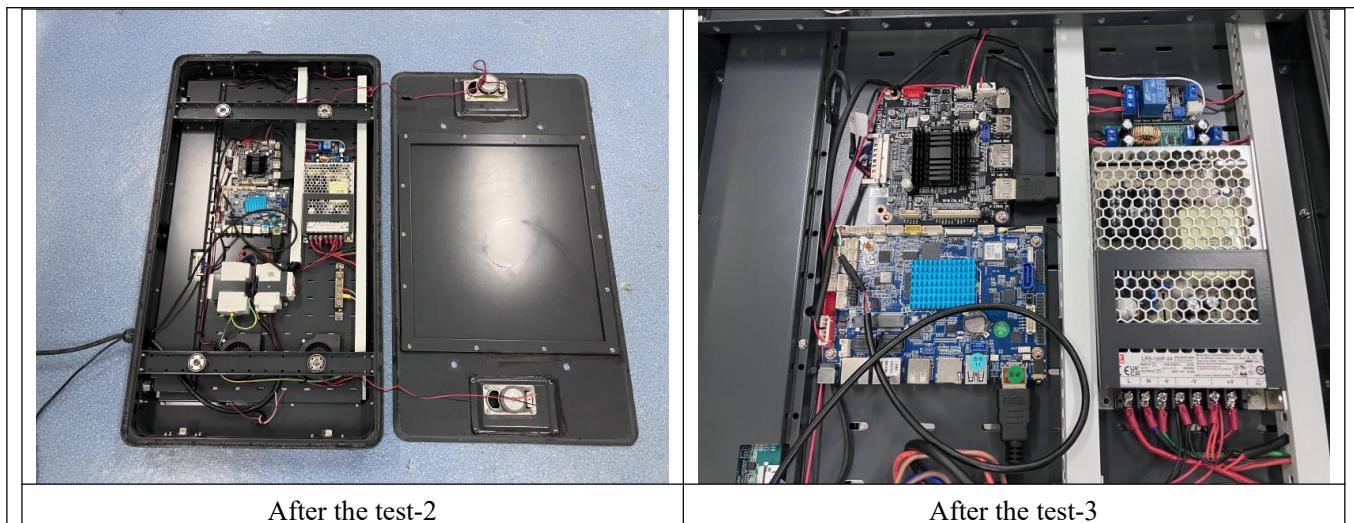
#### 4) Test data:

1. Dust: talc powder (75  $\mu$  m);
2. Test time: 8h continuous dust blowing;
3. Concentration: 2 kg/m<sup>3</sup>;
4. Sample status during the test: the sample does not work during the test;
5. Sample status: storage;

After the IP6X dustproof test, no dust entered the interior of the sample.

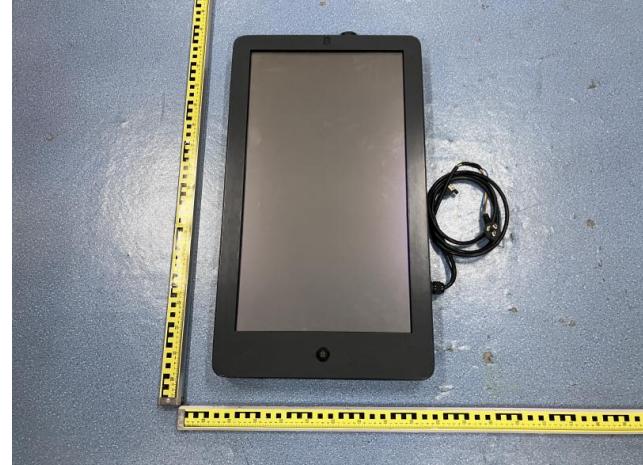
Before the test	During the test-1

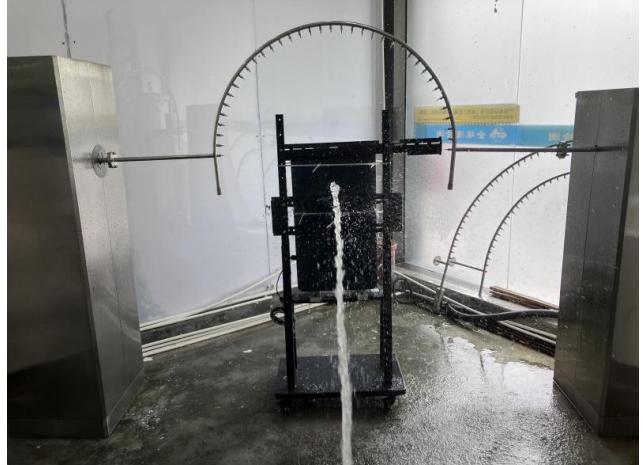
1. Nozzle diameter: 6.3mm;
2. Water spray distance: 2.5m~3m;
3. Total flow rate: 12.5L/min;
4. Test time: 5 min.

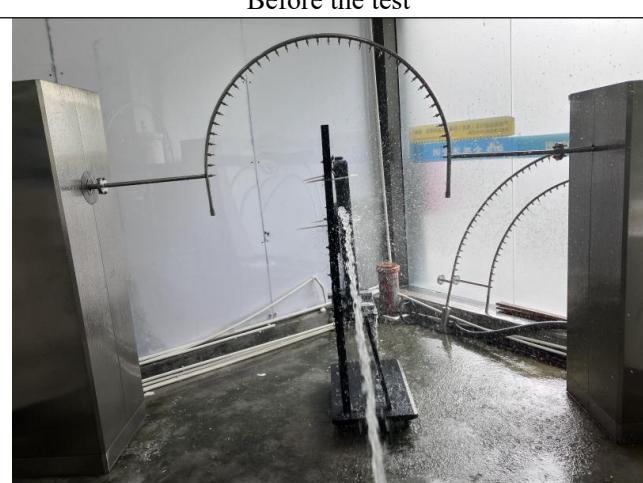
During the test-2	After the test-1

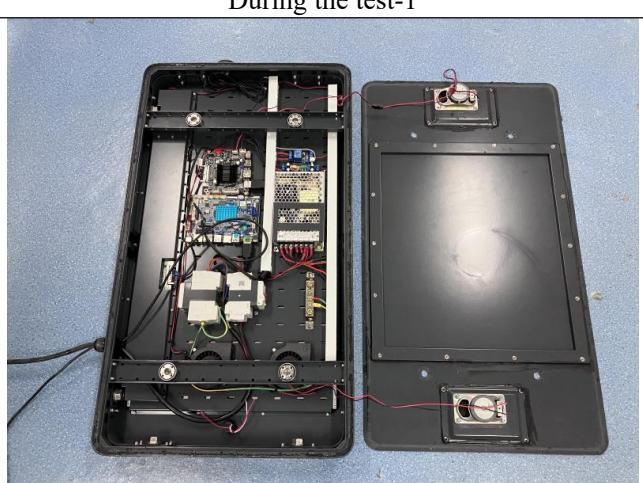
After the IPX5 waterproof test, no water seeped into the interior of the sample.

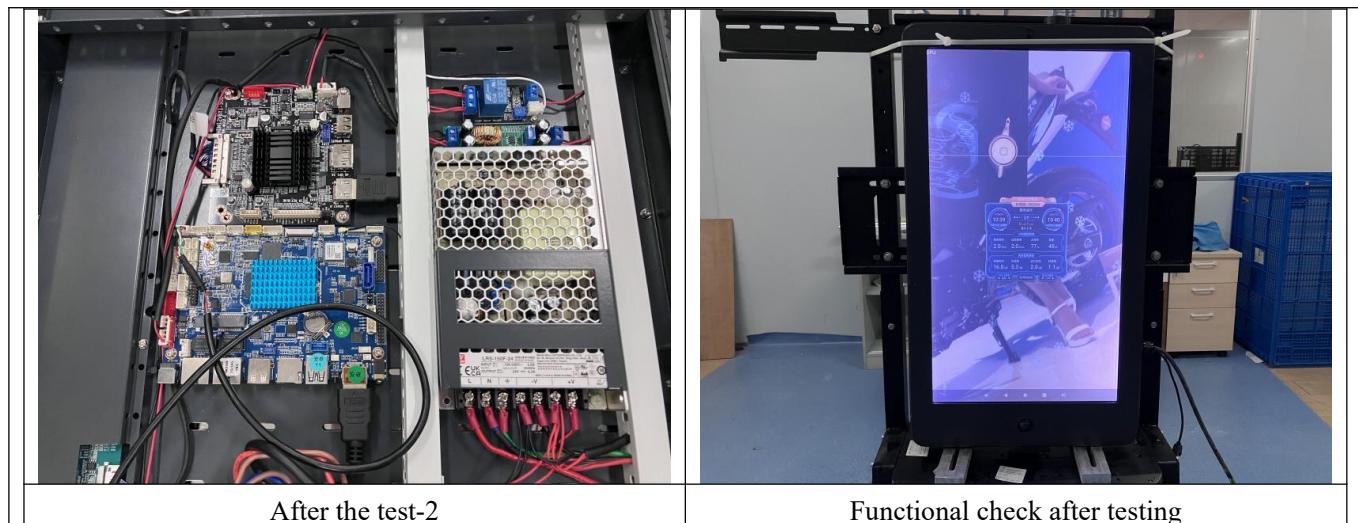
After the test-2

Functional check after testing
